October 6, 2005

M. E. Simpson Company is pleased to submit this report of our leak detection survey for the City of Brazil. This survey addressed the Brazil water distribution system, consisting of approximately 73 miles of water main. The report contains the results of our investigation that includes the following:

## LEAK LOCATION REPORT

**Client:** Brazil, Indiana

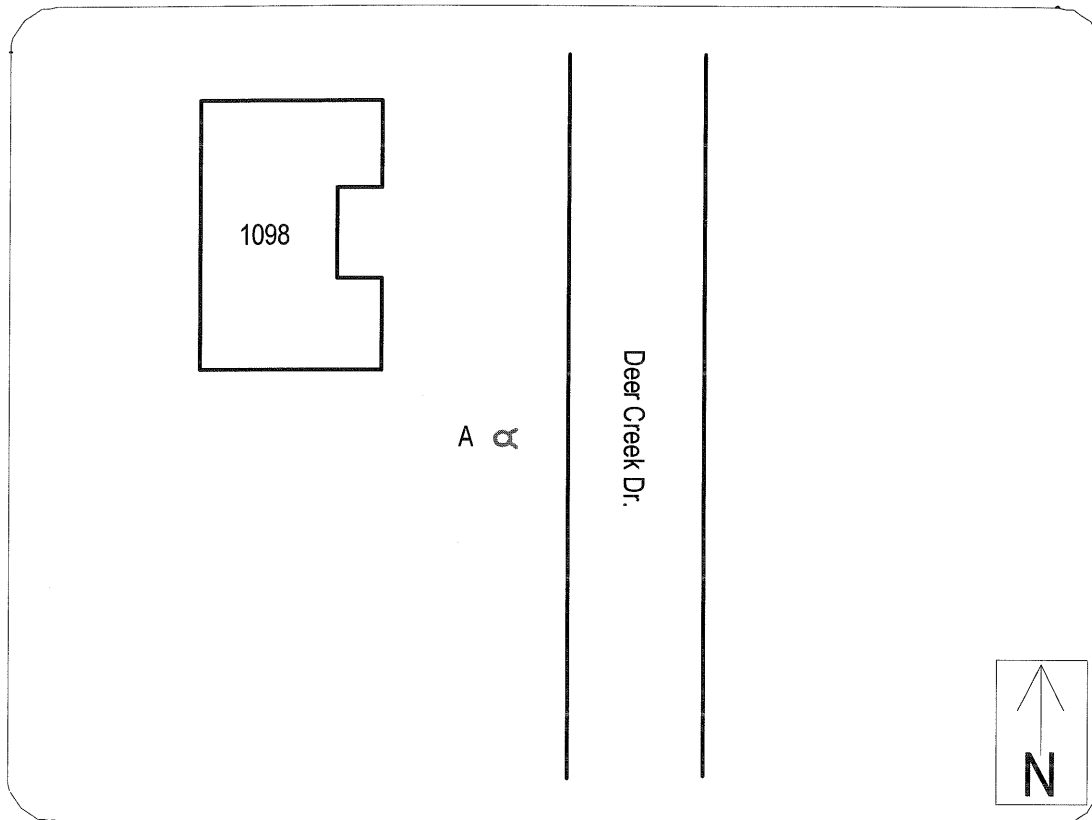
**Address:** 1098 Deer Creek Drive

**Leak Location:** 0' from A

**Comments:** This was a hydrant leak. We tightened the hydrant top nut and the leak noise quit. This leak is fixed.

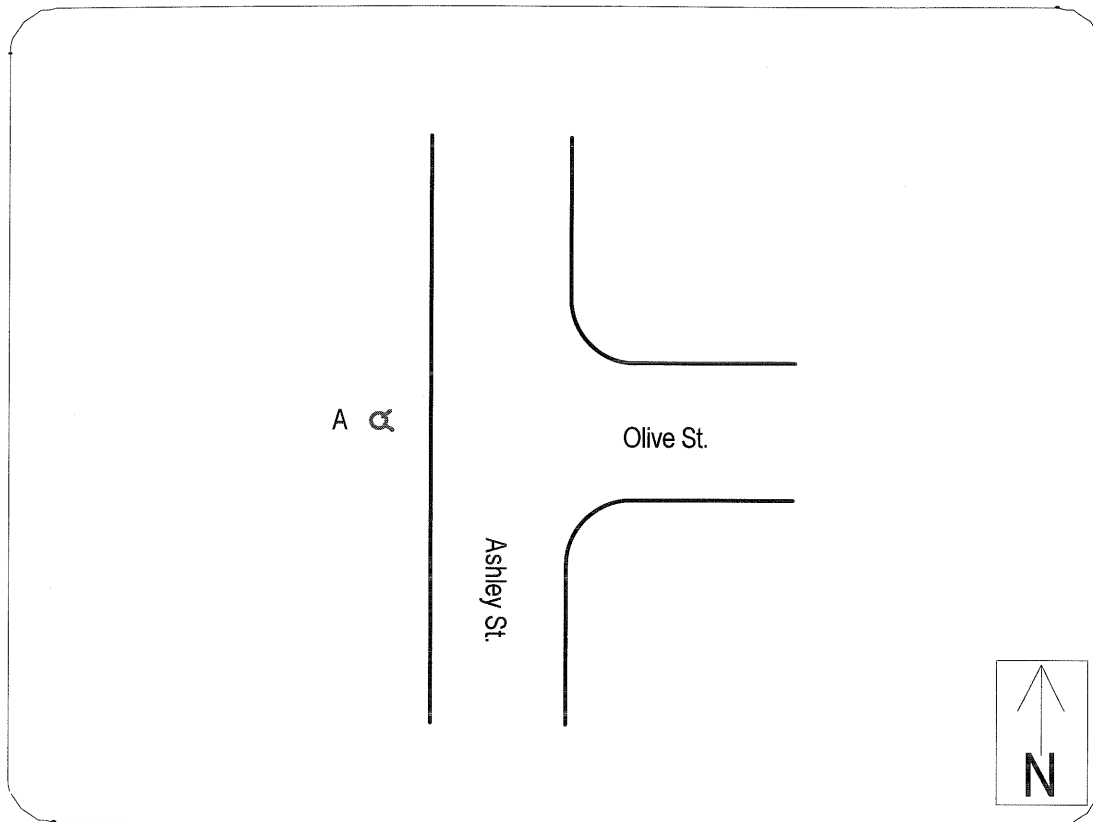
**Address:** Ashley Street & Olive Street

**Leak Location:** 0' from A

**Comments:** This is a hydrant leak.

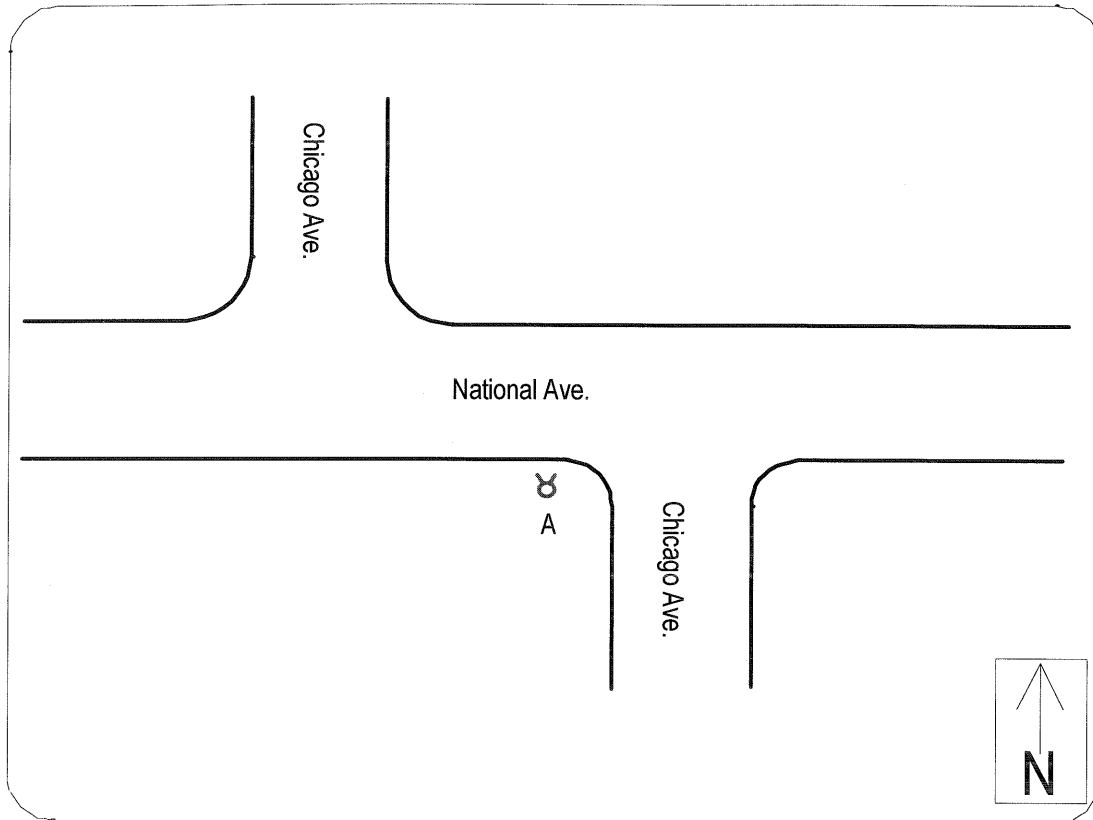
**Address:** Chicago Avenue & National Avenue

**Leak Location:** 0' from A

**Comments:** This is a hydrant leak.

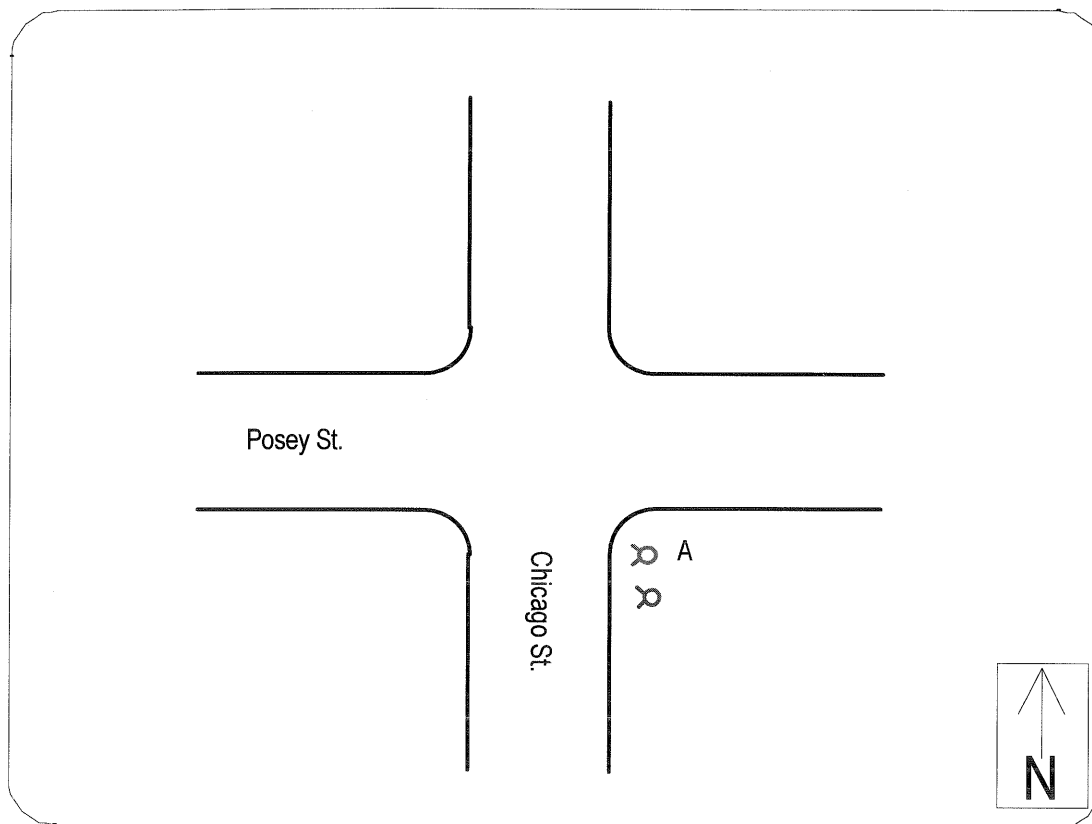
**Address:** Chicago Street & Posey Street

**Leak Location:** 0' from A

**Comments:** This was a hydrant leak. We tightened the hydrant top nut and the leak noise quit. This leak is fixed.

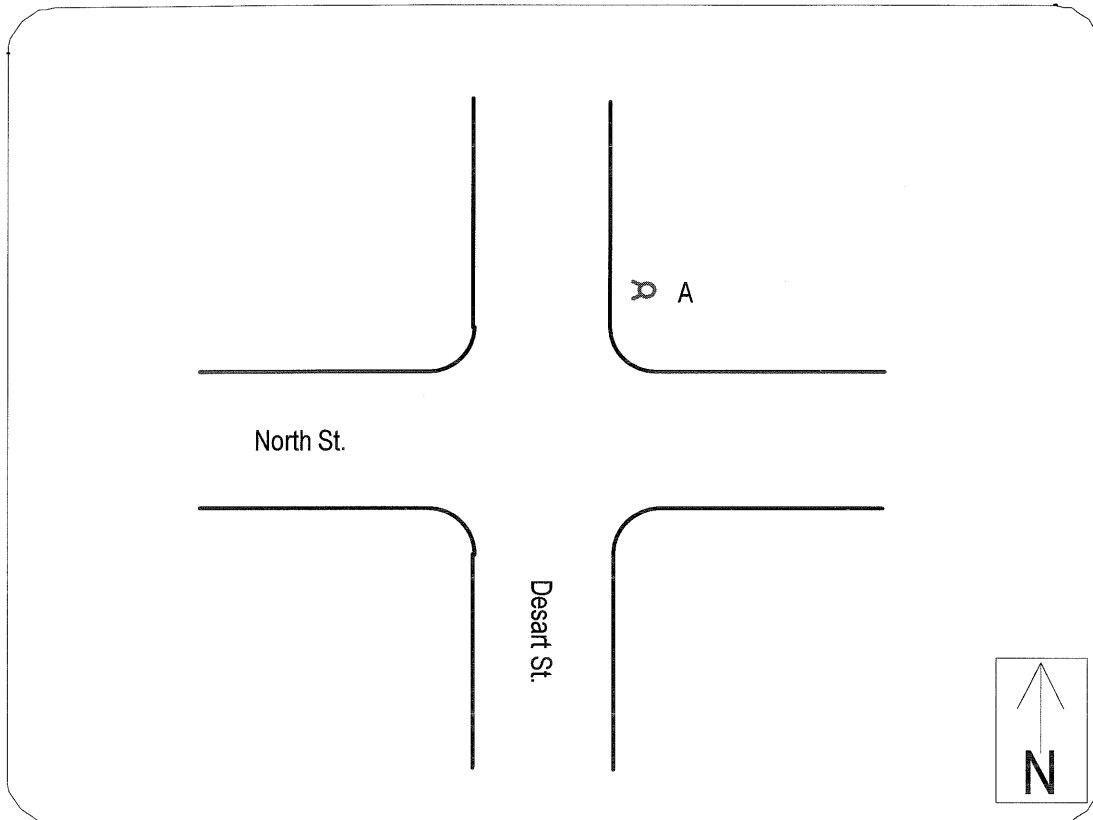
**Address:** Desart Street & North Street

**Leak Location:** 0' from A

**Comments:** This is a hydrant leak.

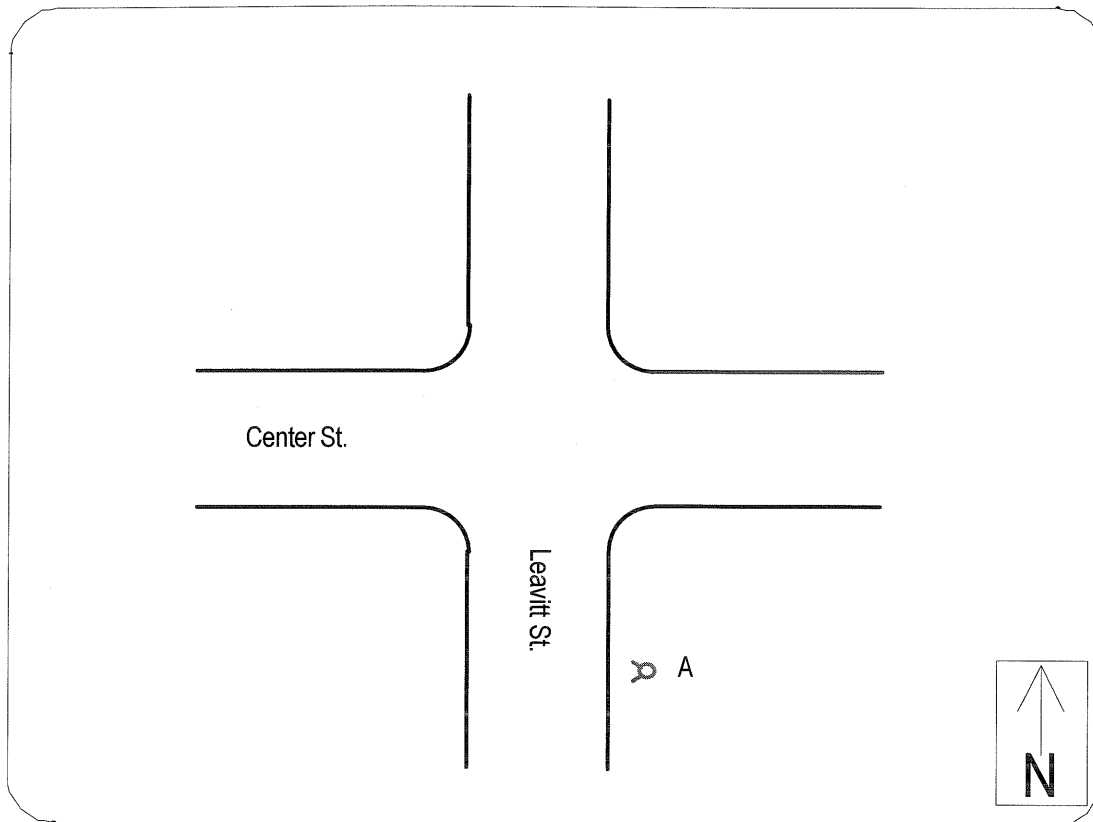
**Address:** Leavitt Street & Center Street

**Leak Location:** 0' from A

**Comments:** This is a hydrant leak.
